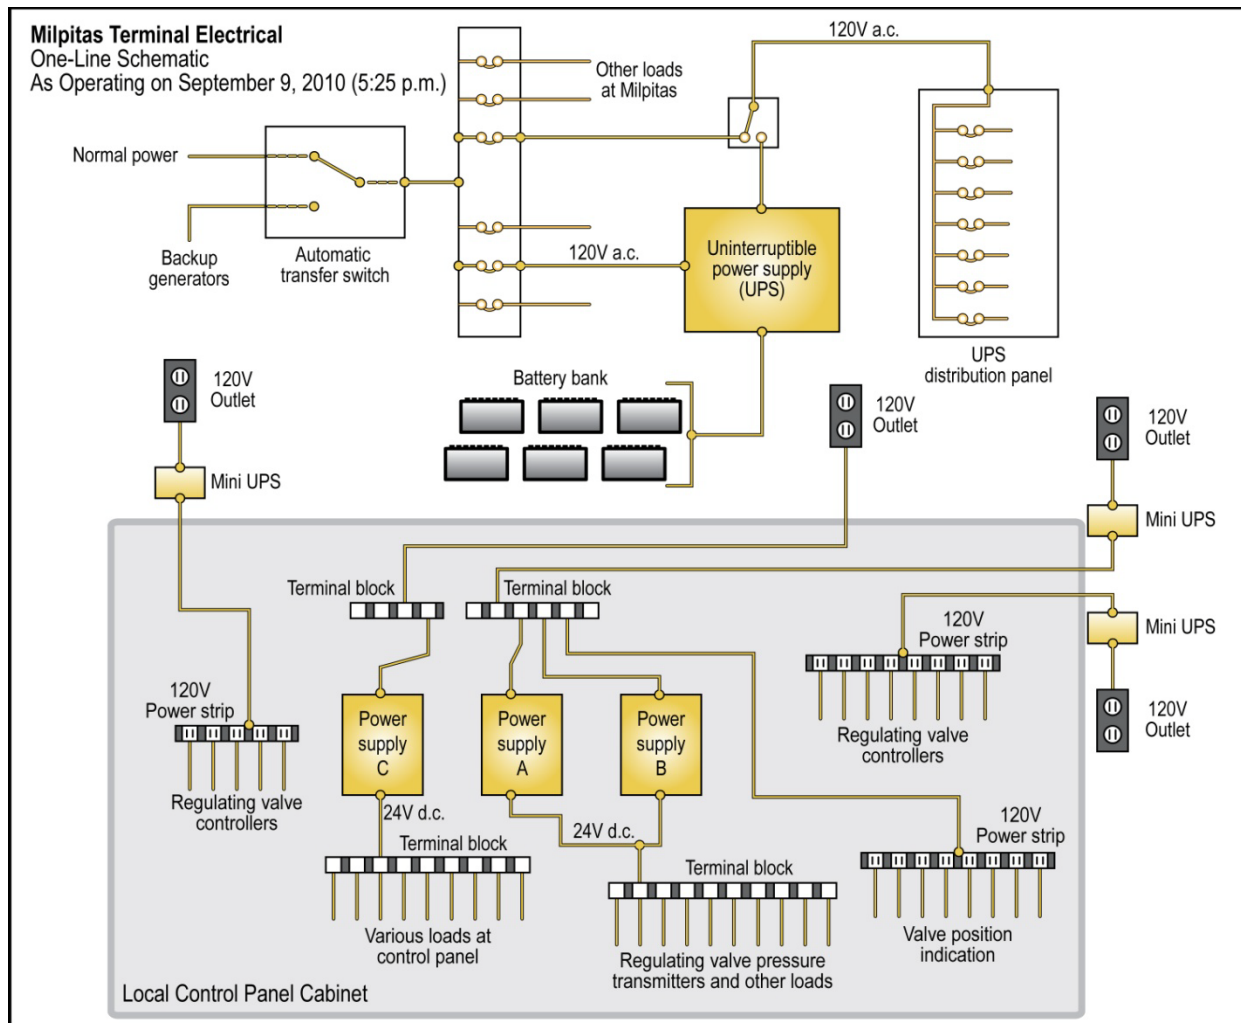
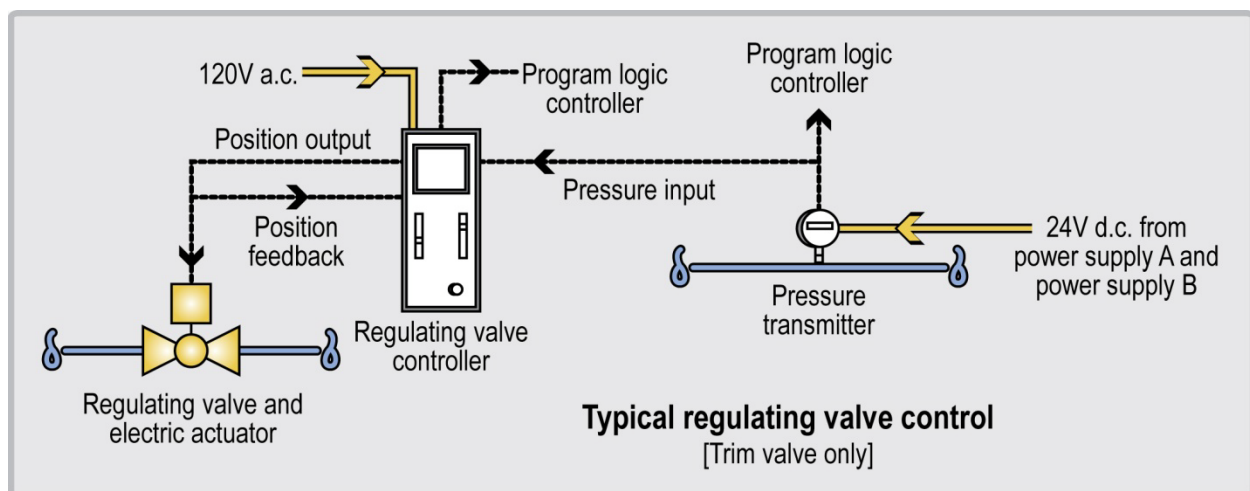
At 5:22 p.m., as a result of regulating valves fully opening and the erroneous signals caused by the erratic voltages, the SCADA center alarm console displayed over 60 alarms within a few seconds, including controller error alarms and high differential pressure and backflow alarms from the Milpitas Terminal. (See figure 8a.) These alarms were followed by high and high-high pressure alarms¹³ on several lines leaving the Milpitas Terminal, including Line 132. At 5:25 p.m., SCADA operator C called the Milpitas technician to report the high pressure alarms, stating that they “look real.” During this conversation, the Milpitas technician realized that the pressure and regulating valve controller displays on the local control panel had lost all data. At the same time, the SCADA consoles displayed constant pressures¹⁴ on the downstream lines and showed all regulating and a majority of monitor and incoming line valves¹⁵ at the Milpitas Terminal as not open.¹⁶ (See figure 8b.)
